S-13257  
NPIC/R-1269/64  
July 1964

PHOTOGRAPHIC INTERPRETATION REPORT

# MUNITIONS STORAGE SITE WEST OF SHANG-JAO, CHINA

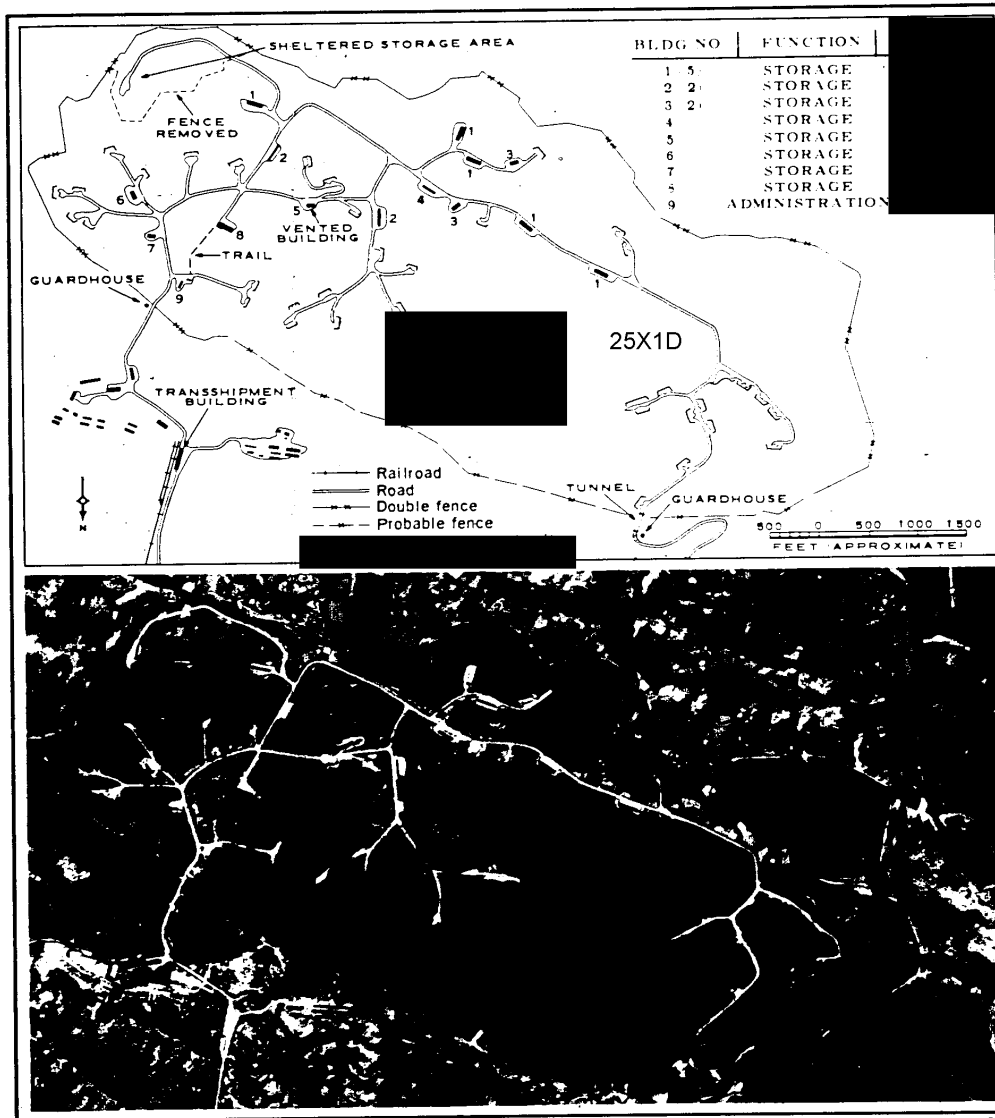
FIGURE 2. MUNITIONS STORAGE SITE WEST OF SHANG-JAO, CHINA.

entrance and exit. The site also contains 14 storage buildings of various sizes (Figure 2).

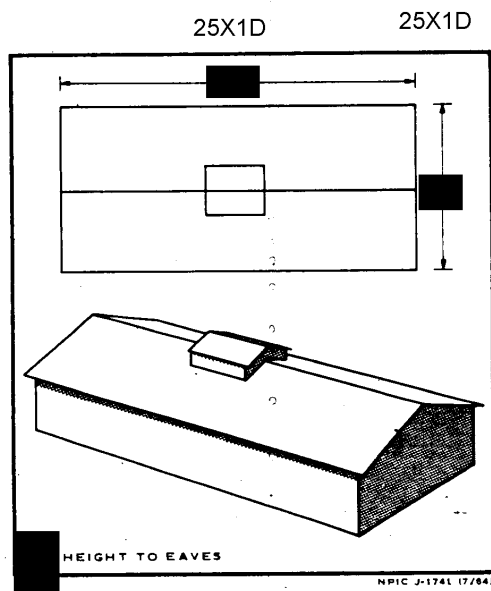
FIGURE 3. PLAN AND PERSPECTIVE VIEWS OF BUILDING 5.

None of the buildings are revetted; however, they are situated in terrain that provides natural blast protection. Adjacent service aprons permit easy access to the buildings. The number of doorways in each building cannot be determined. One storage building (item 5) has a single, low, gable-type roof ventilator (Figure 3).
